PHOTOGRAPHIC LOG

PHOTOGRAPH LOG ROLL 10
AMERICAN CHEMICAL SERVICES

ROLL #11 PHOTOGRAPH LOG
AMERICAN CHEMICAL SERVICES
12 March to 16 March 1990

ROLL #12 PHOTOGRAPH LOG
AMERICAN CHEMICAL SERVICES
19 MARCH TO 26 MARCH 1990

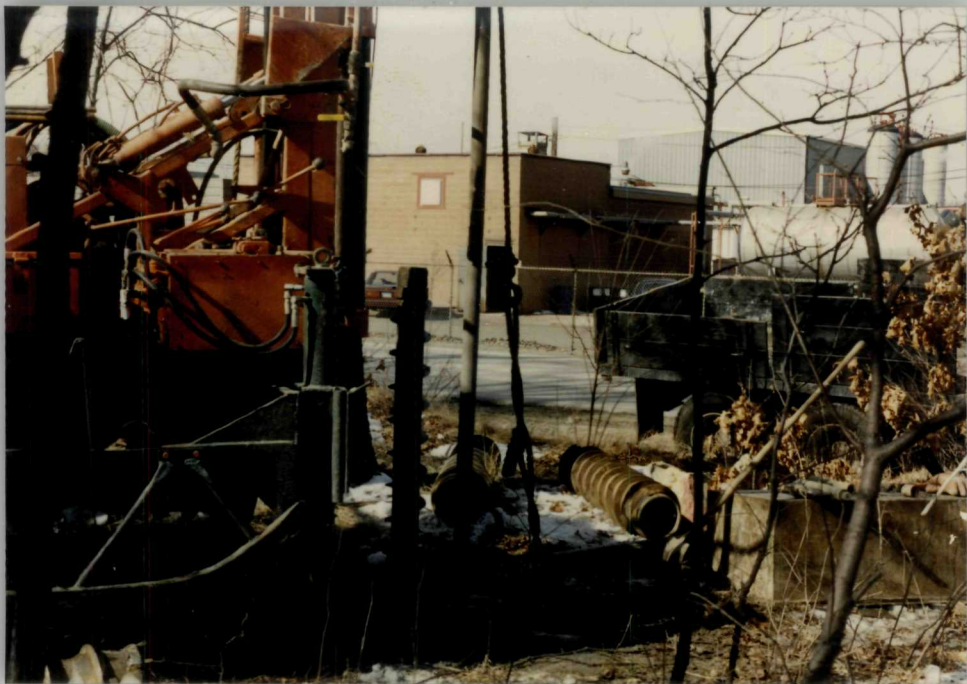
| <u>Photo Number</u> | <u>Description</u> | <u>Date</u> |
|---|--|---|
| R10-2 | Location of MW-07, initial location, view to north. | 3-7-90 |

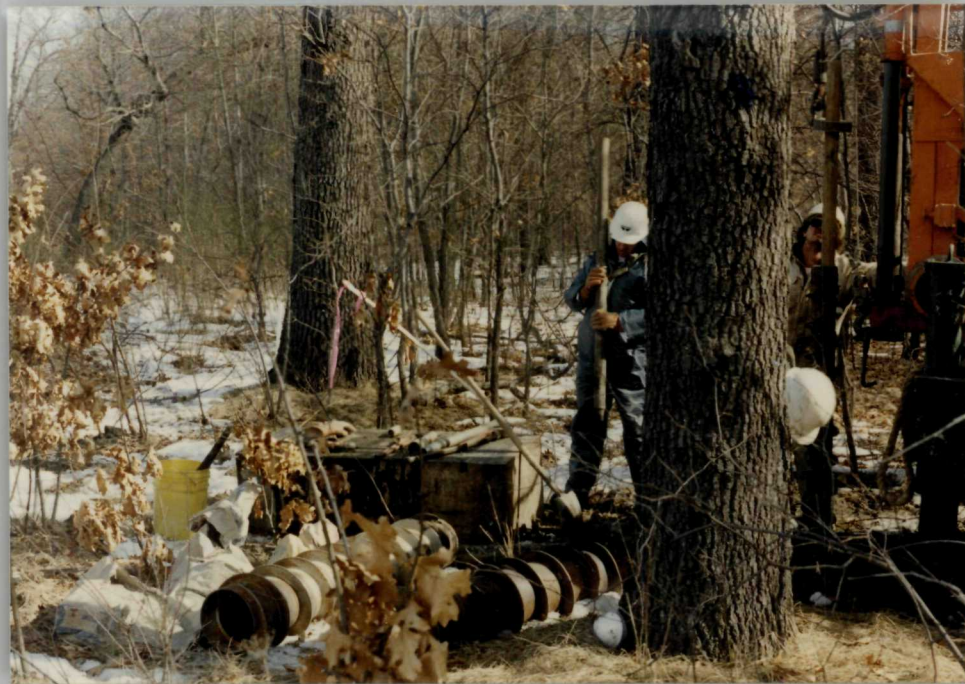
| <u>Photo Number</u> | <u>Description</u> | <u>Date</u> |
|---|--|---|
| R10-1 | Location of MW-07, initial location, ACS & Piezometer P-7 in background. | 3-7-90 |

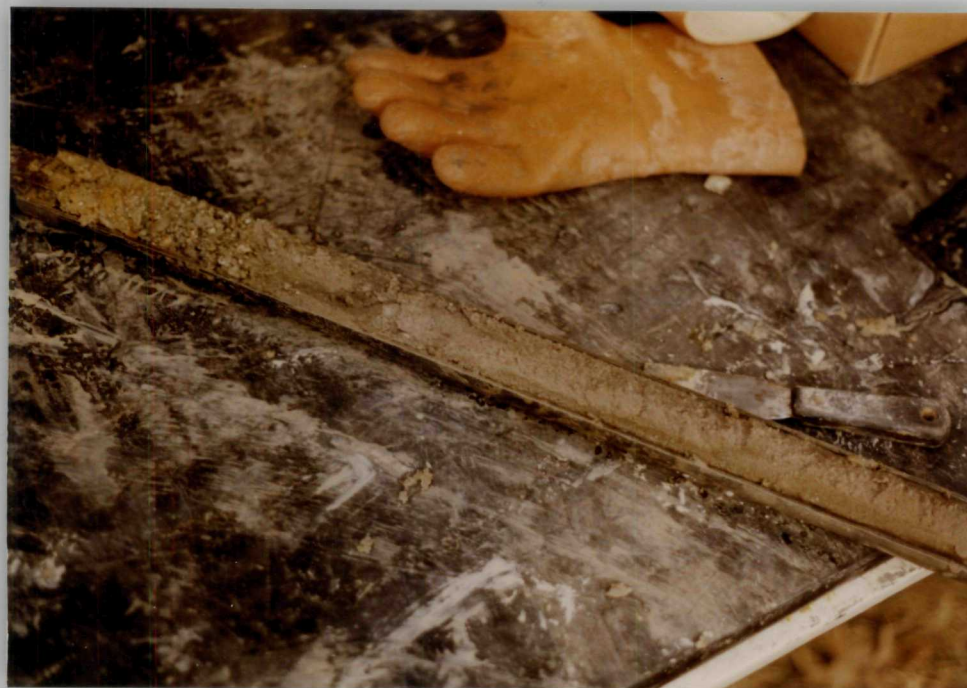
| <u>Photo Number</u> | <u>Description</u> | <u>Date</u> |
|---|--|---|
| R10-4 | Split spoon sample of MW-7, 10 to 12 feet. | 3-7-90 |

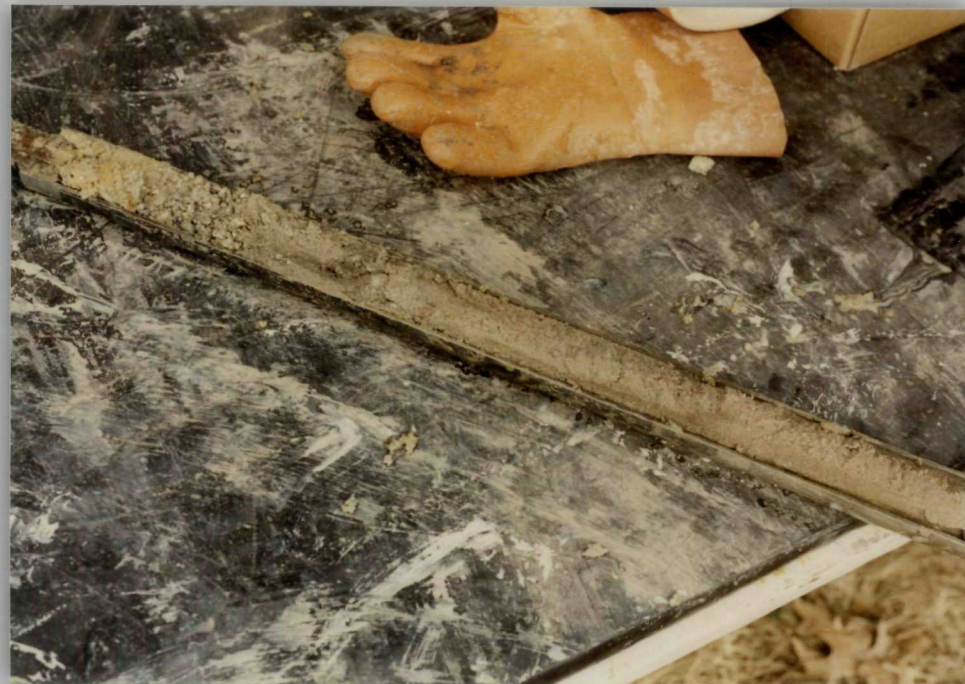
| <u>Photo Number</u> | <u>Description</u> | <u>Date</u> |
|---|--|---|
| R10-3 | Split spoon sample of MW-7, 10 to 12 feet. | 3-7-90 |

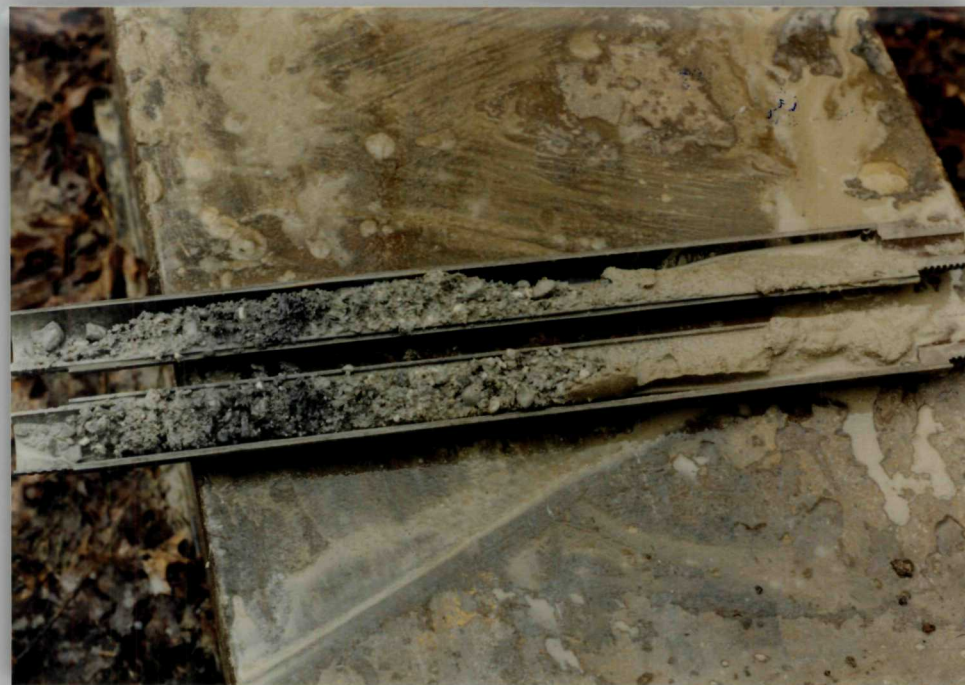
| <u>Photo Number</u> | <u>Description</u> | <u>Date</u> |
|---|--|---|
| R10-9 | Split spoon sample of MW-8, 10 to 12 feet. | 3-8-90 |

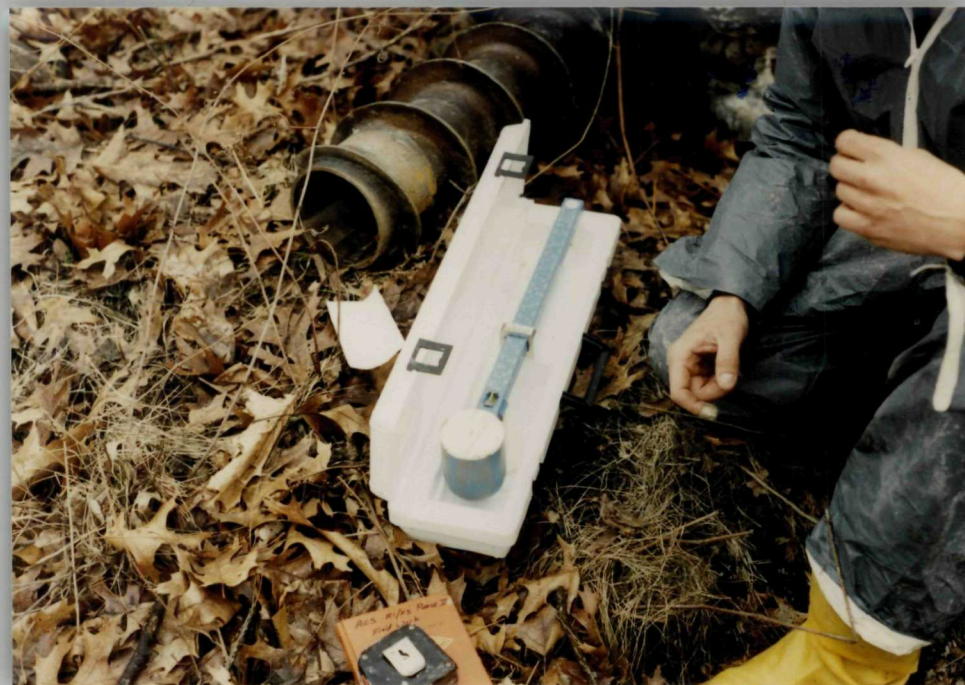
| <u>Photo Number</u> | <u>Description</u> | <u>Date</u> |
|---|--|---|
| R10-13 | Mixing grout of MW-08. | 3-8-90 |

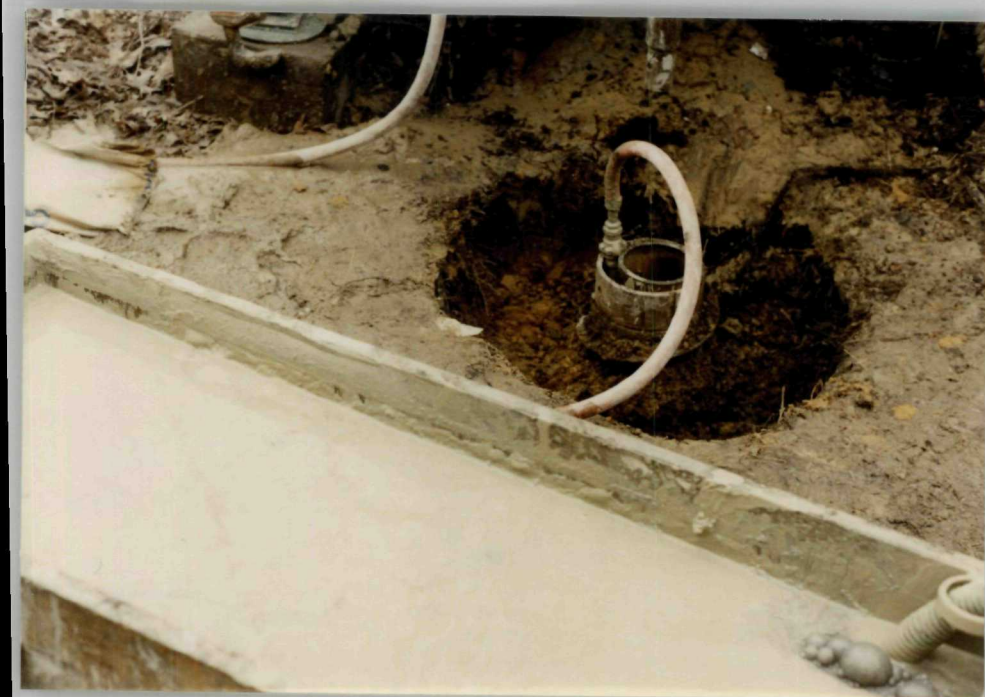
| <u>Photo Number</u> | <u>Description</u> | <u>Date</u> |
|---|--|---|
| R10-15 | Grouting outer casing of MW-08. | 3-8-90 |

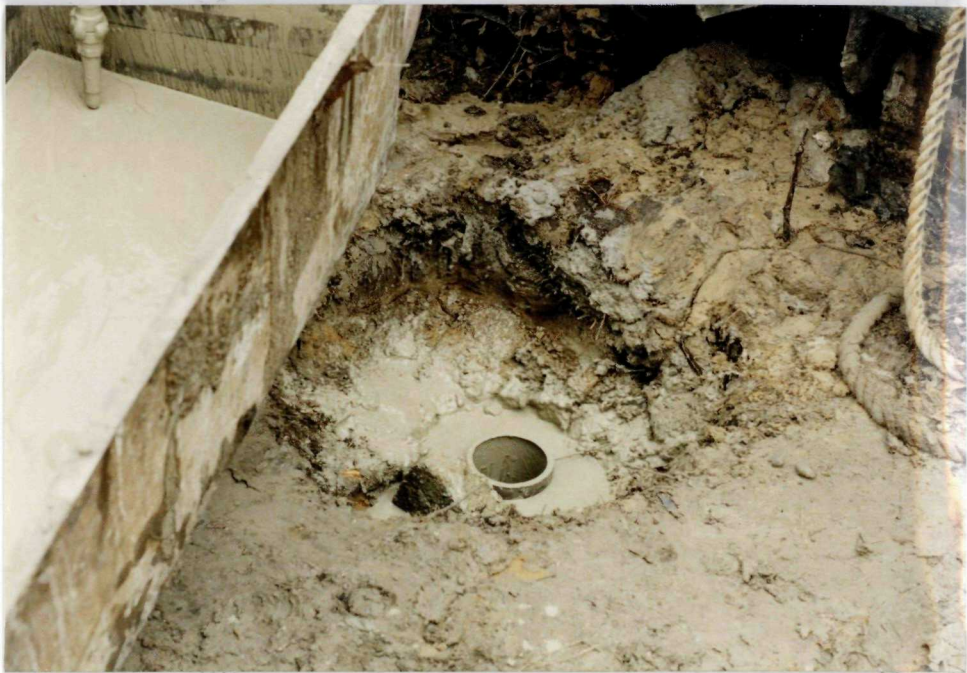
| <u>Photo Number</u> | <u>Description</u> | <u>Date</u> |
|---|--|---|
| R10-17 | Grouted outer casing of MW-08. | 3-8-90 |

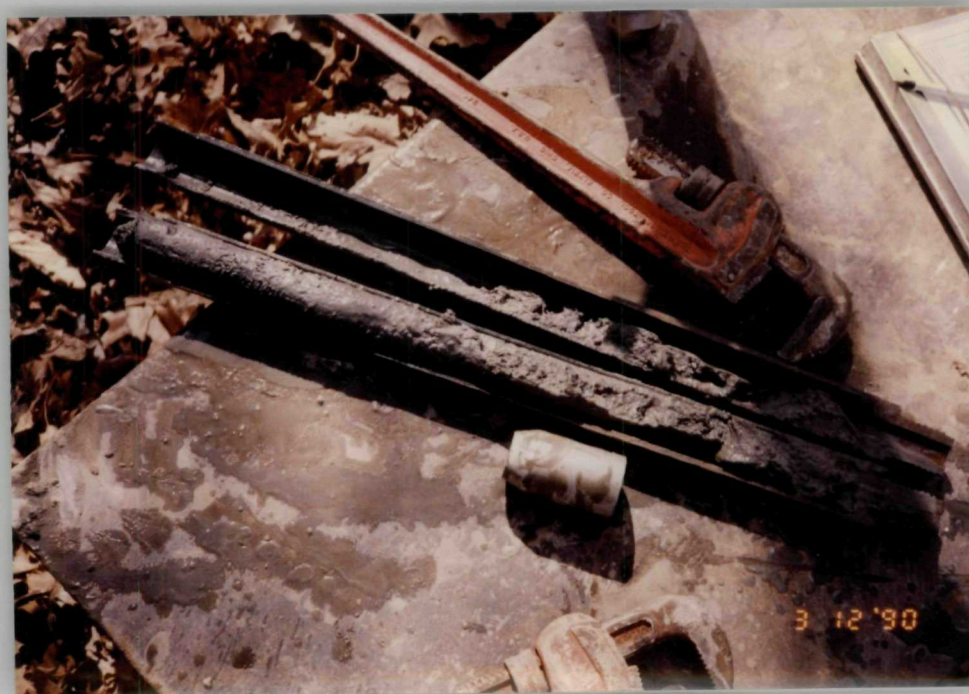
| <u>NUMBER</u> | <u>DESCRIPTION</u> | <u>DATE</u> |
|---|---|---|
| R11-4 | Split spoon sample MW-9. 15 to 17 feet. | 3/12/90 |

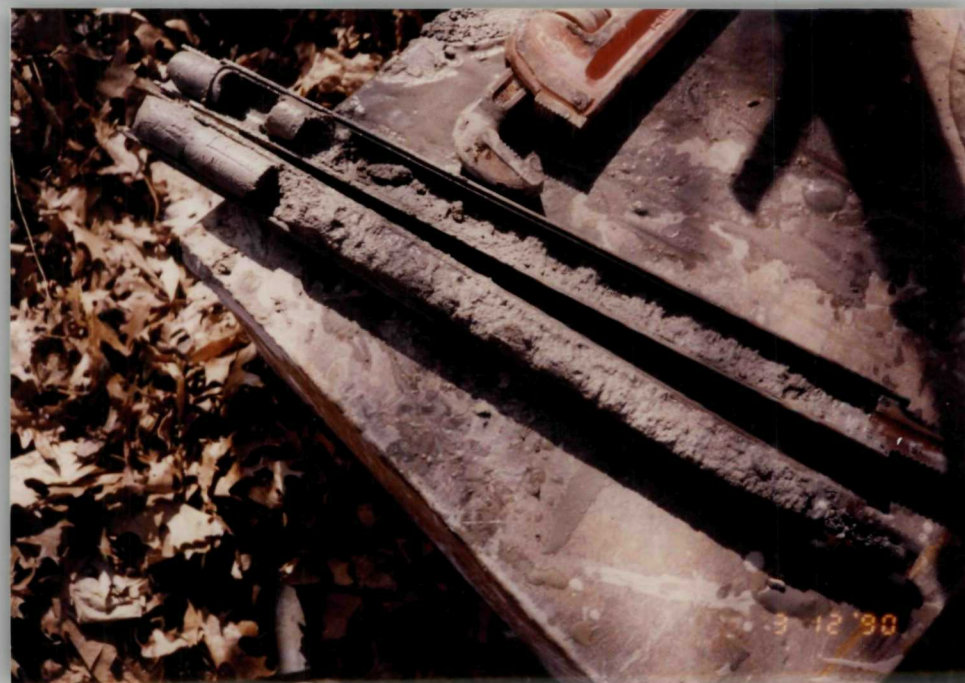
R11-3

| <u>NUMBER</u> | <u>DESCRIPTION</u> | <u>DATE</u> |
|---|---|---|
| R11-2 | Split spoon sample MW-9. 10 to 12 feet. | 3/12/90 |

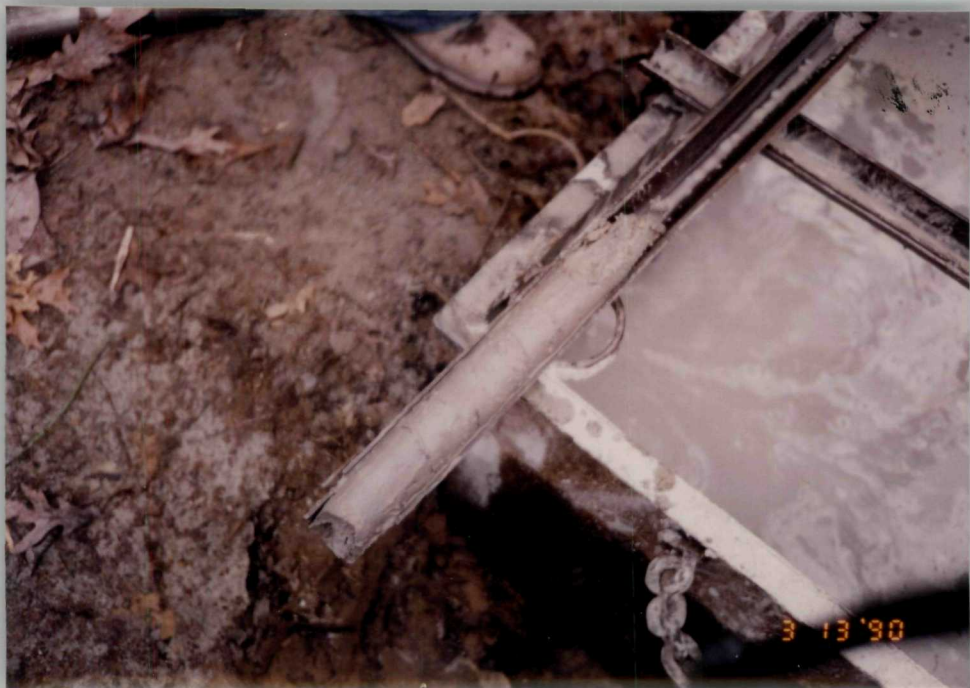
| <u>NUMBER</u> | <u>DESCRIPTION</u> | <u>DATE</u> |
|---|---|---|
| R11-8 | Split spoon sample MW-7. 25 to 27 feet. | 3/13/90 |

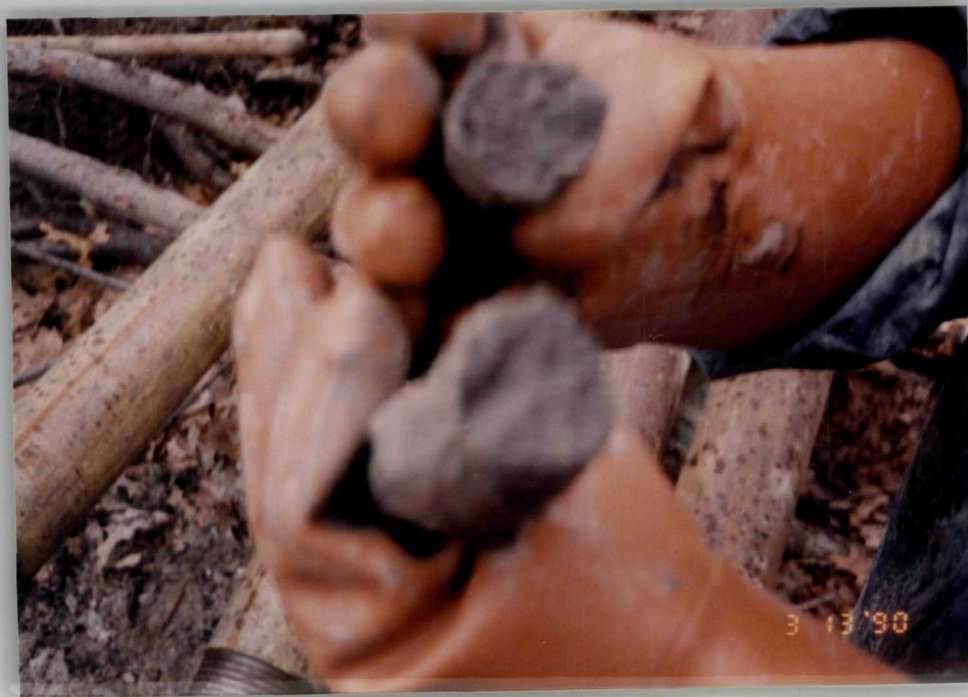
| <u>NUMBER</u> | <u>DESCRIPTION</u> | <u>DATE</u> |
|---|---|---|
| R11-7 | Split spoon sample MW-7. 21.5 to 23 feet. | 3/13/90 |

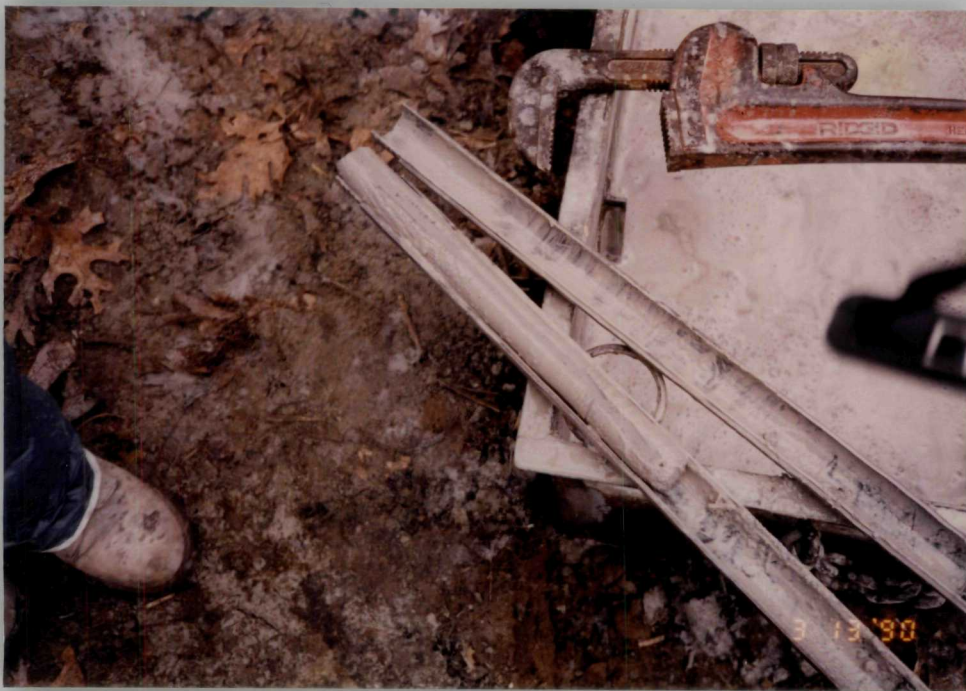
| <u>NUMBER</u> | <u>DESCRIPTION</u> | <u>DATE</u> |
|---|---|---|
| R11-10 | Split spoon sample MW-7. 29 to 31 feet. | 3/13/90 |

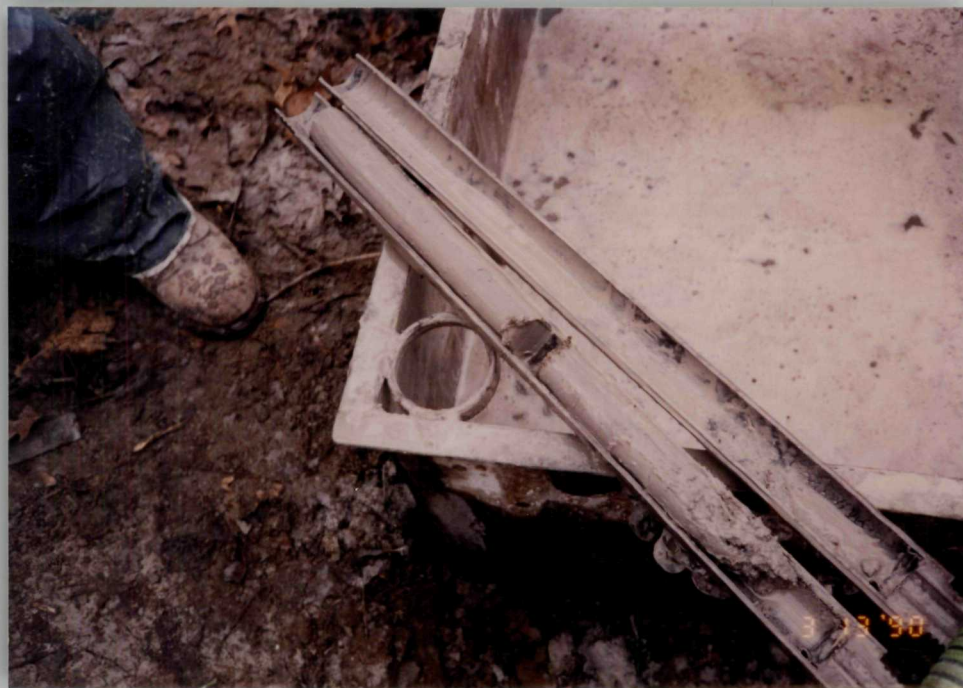
| <u>NUMBER</u> | <u>DESCRIPTION</u> | <u>DATE</u> |
|---|---|---|
| R11-9 | Split spoon sample MW-7. 27 to 29 feet. | 3/13/90 |

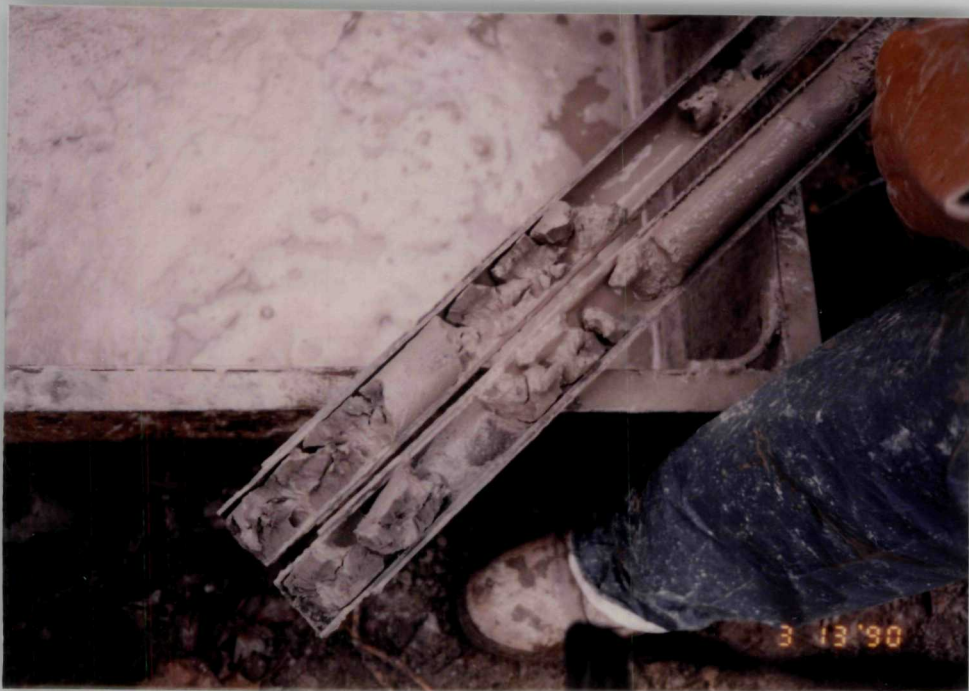
| <u>NUMBER</u> | <u>DESCRIPTION</u> | <u>DATE</u> |
|---|---|---|
| R11-12 | Split spoon sample MW-7. 37 to 39 feet. | 3/13/90 |

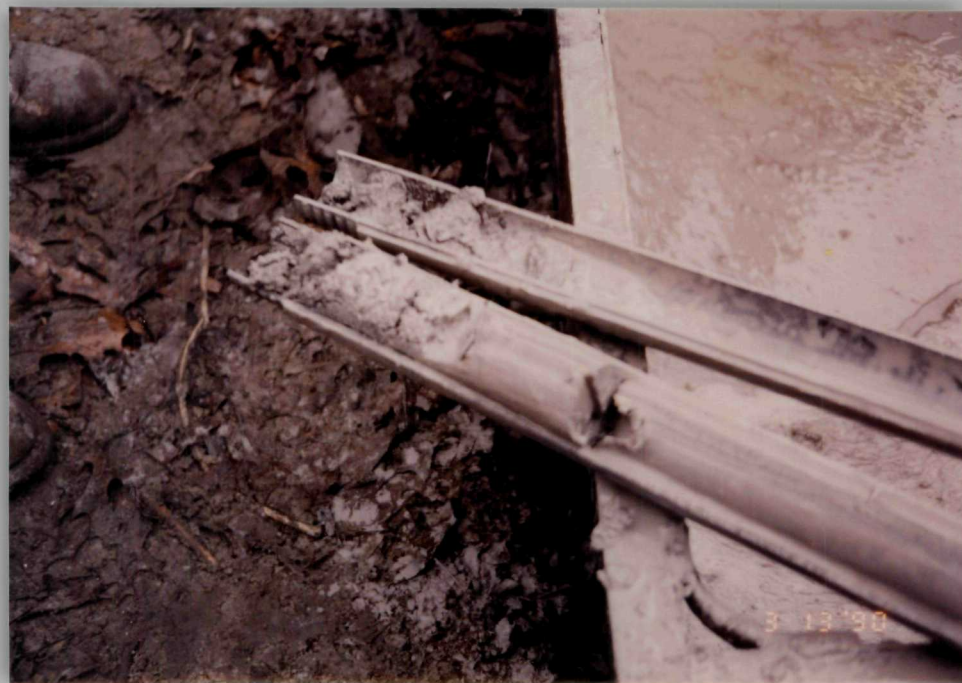
| <u>NUMBER</u> | <u>DESCRIPTION</u> | <u>DATE</u> |
|---|---|---|
| R11-11 | Split spoon sample MW-7. 31 to 33 feet. | 3/13/90 |

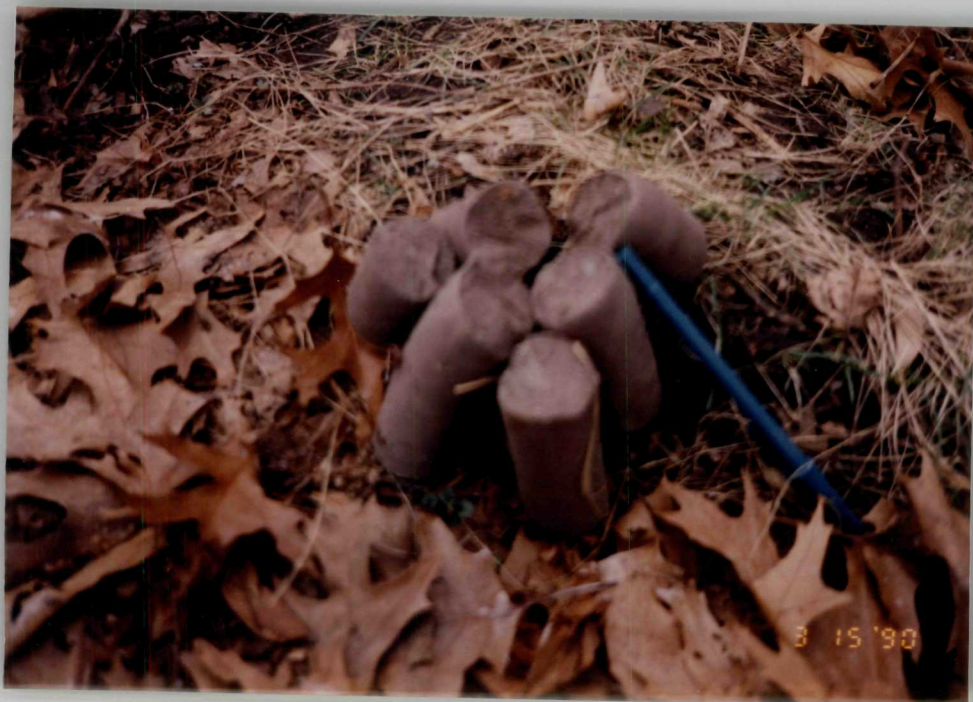
| <u>NUMBER</u> | <u>DESCRIPTION</u> | <u>DATE</u> |
|---|---|---|
| R11-16 | Clay samples taken from MW-8. 23 to 34 ft. | 3/15/90 |

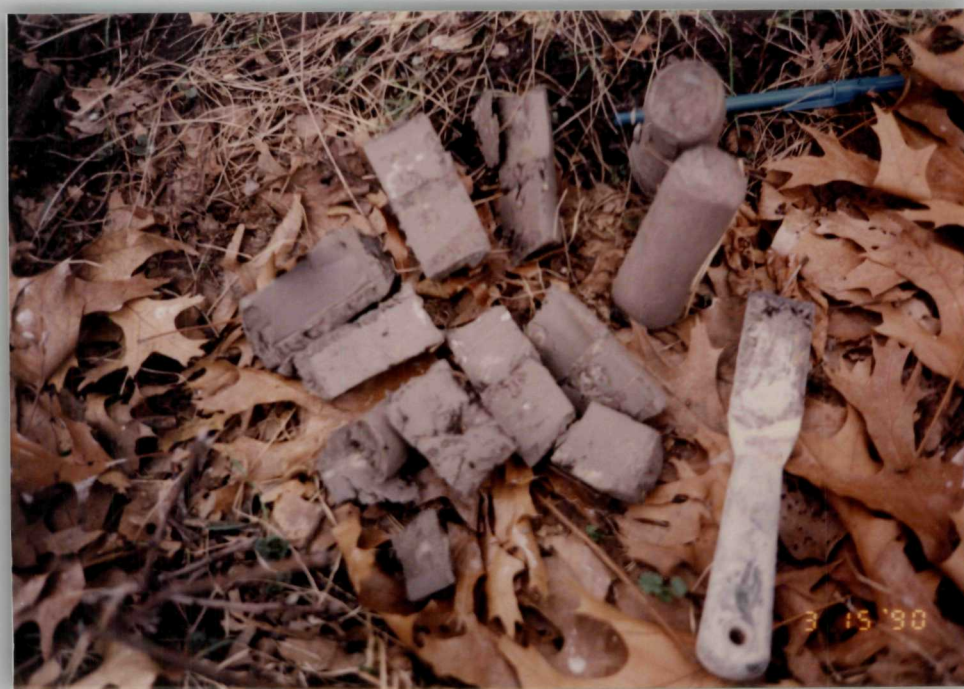
| <u>NUMBER</u> | <u>DESCRIPTION</u> | <u>DATE</u> |
|---|---|---|
| R11-15 | Clay samples taken from MW-8. 23 to 34 ft. | 3/15/90 |

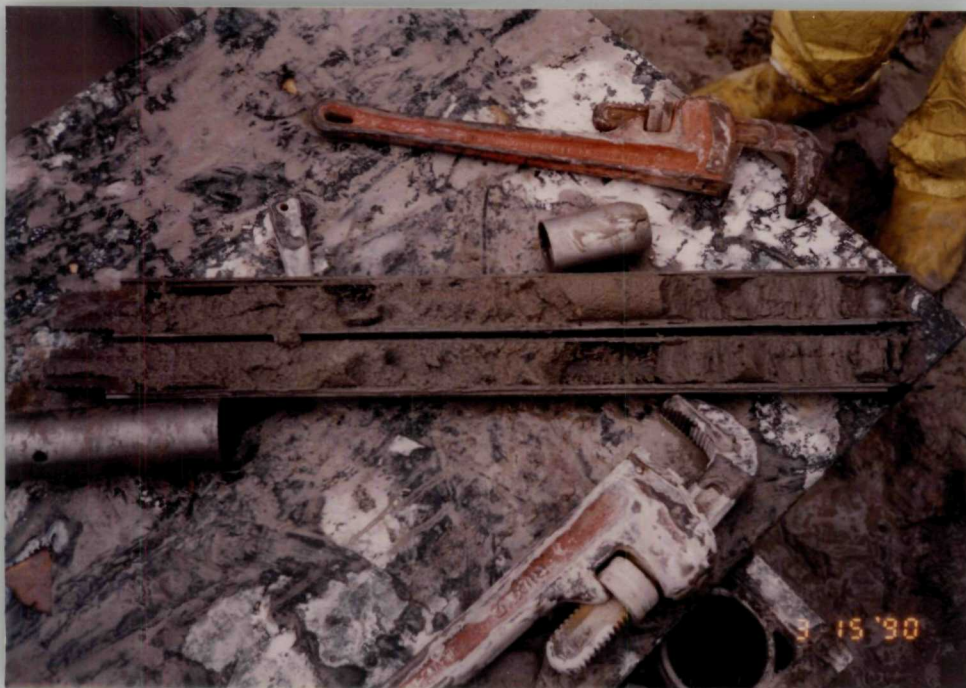
| <u>NUMBER</u> | <u>DESCRIPTION</u> | <u>DATE</u> |
|---|---|---|
| R11-18 | Split spoon sample from MW-8. 37 to 39 ft. | 3/15/90 |

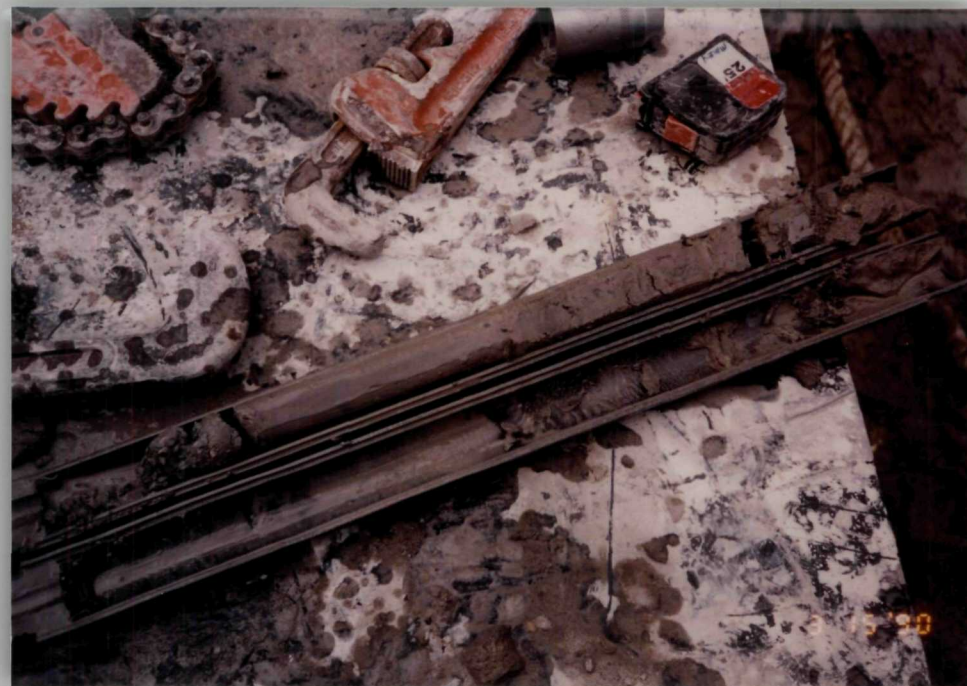
| <u>NUMBER</u> | <u>DESCRIPTION</u> | <u>DATE</u> |
|---|---|---|
| R11-17 | Split spoon sample from MW-8. 34 to 36 ft. | 3/15/90 |

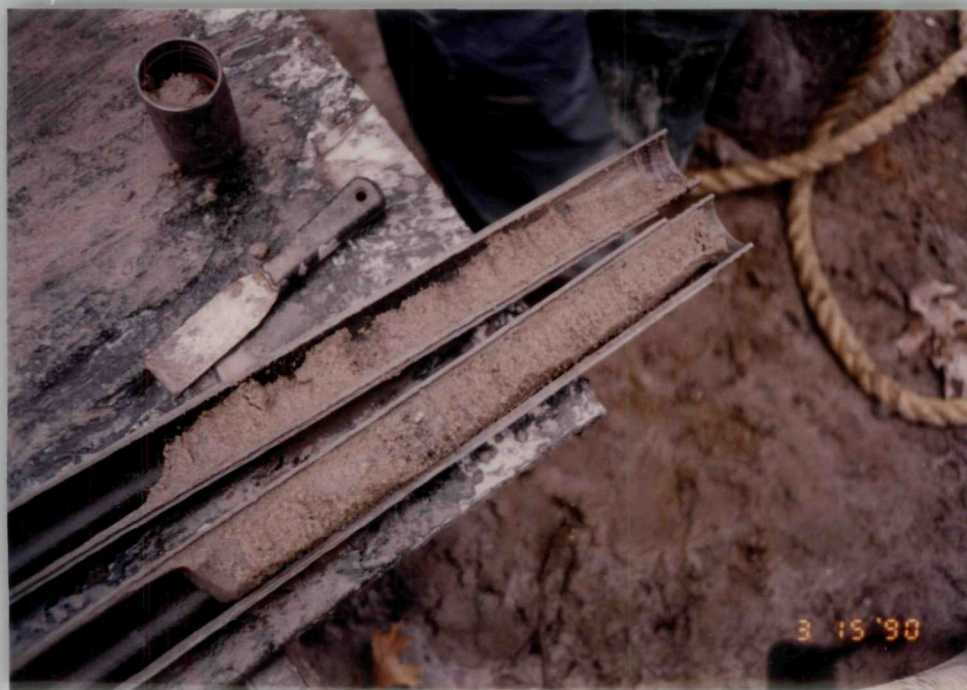
| <u>NUMBER</u> | <u>DESCRIPTION</u> | <u>DATE</u> |
|---|---|---|
| R11-20 | Split spoon sample from MW-8. 43 to 45 ft. | 3/15/90 |

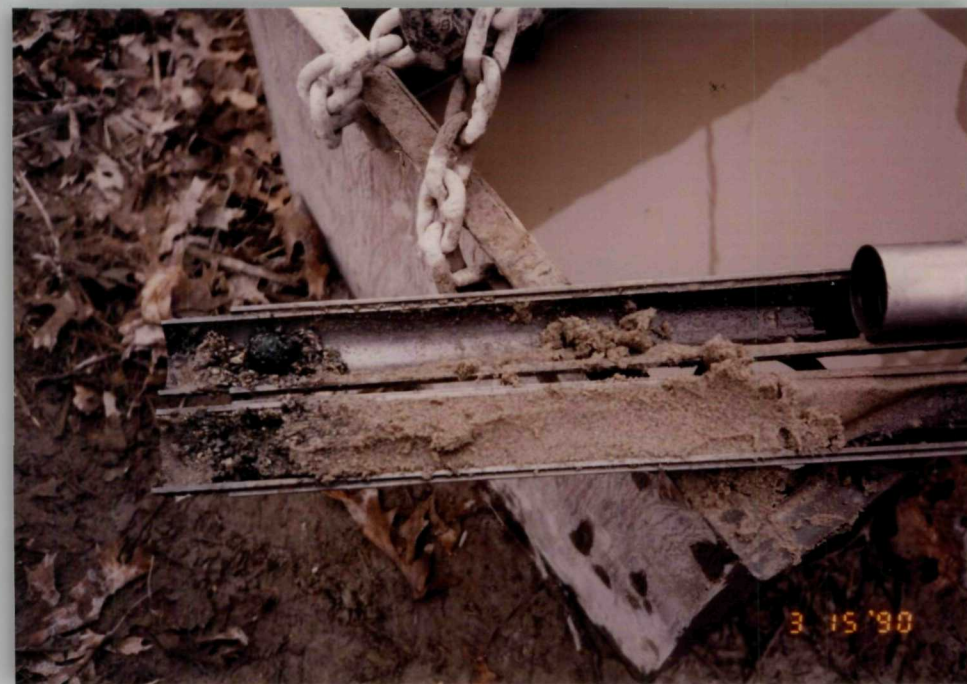
| <u>NUMBER</u> | <u>DESCRIPTION</u> | <u>DATE</u> |
|---|---|---|
| R11-19 | Split spoon sample from MW-8. 39 to 41 ft. | 3/15/90 |

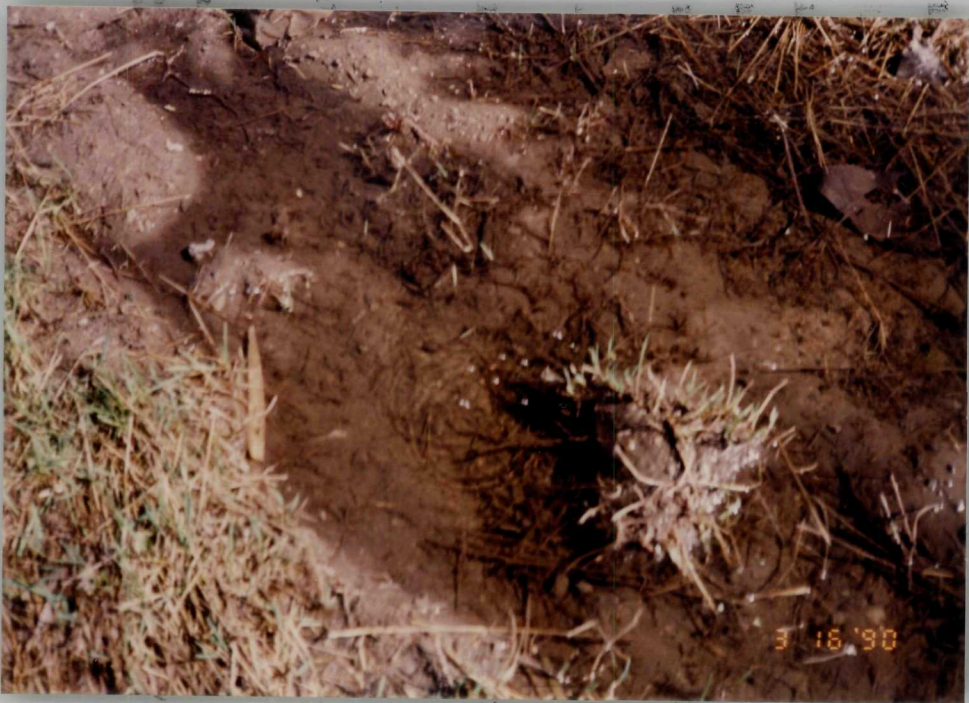
| <u>NUMBER</u> | <u>DESCRIPTION</u> | <u>DATE</u> |
|---|---|---|
| R11-21 | Methane outgassing NW of off-site containment area. | 3/16/90 |

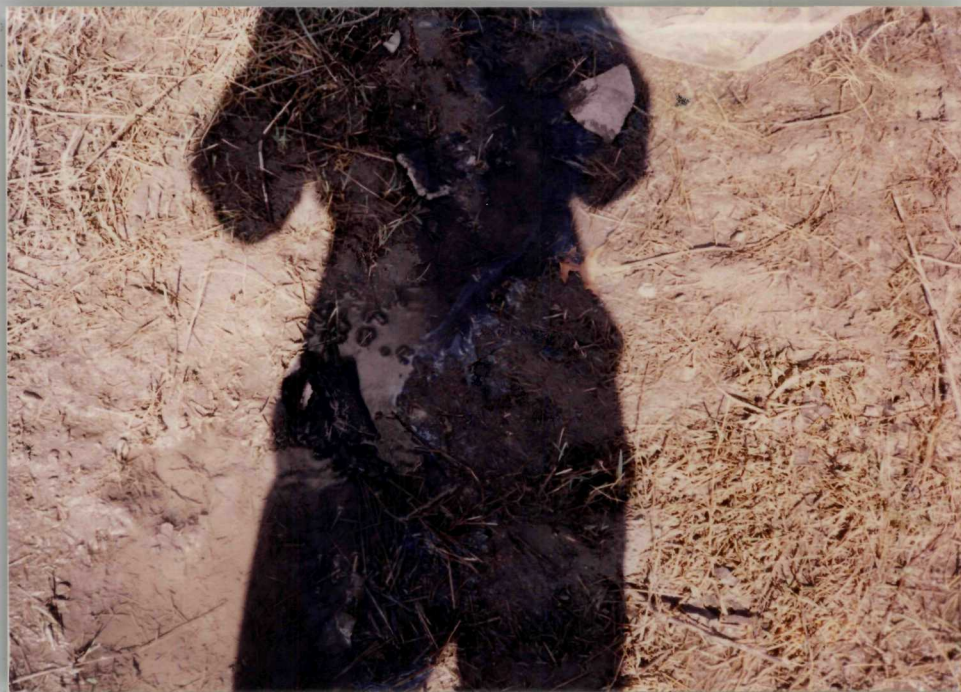
| <u>NUMBER</u> | <u>DESCRIPTION</u> | <u>DATE</u> |
|---|---|---|
| R11-22 | Seeps from slope NW of off-site containment area. | 3/16/90 |

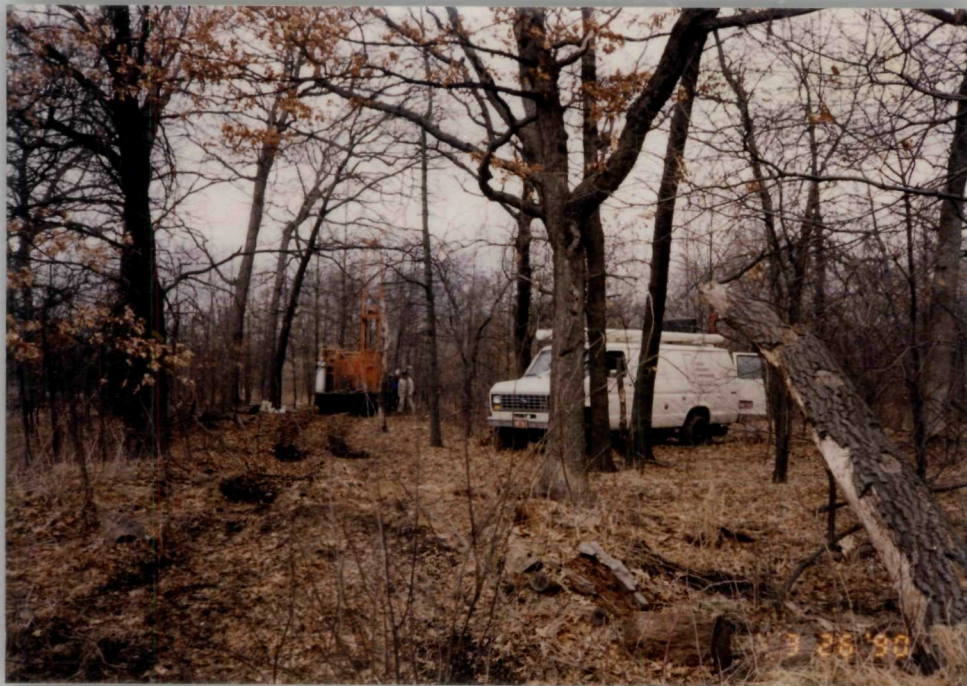
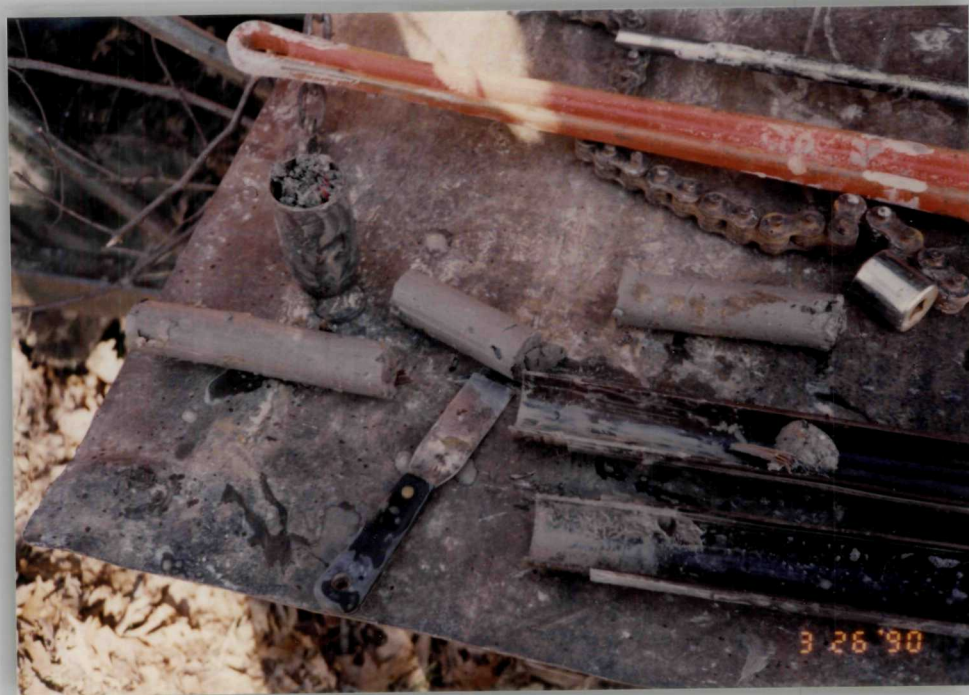
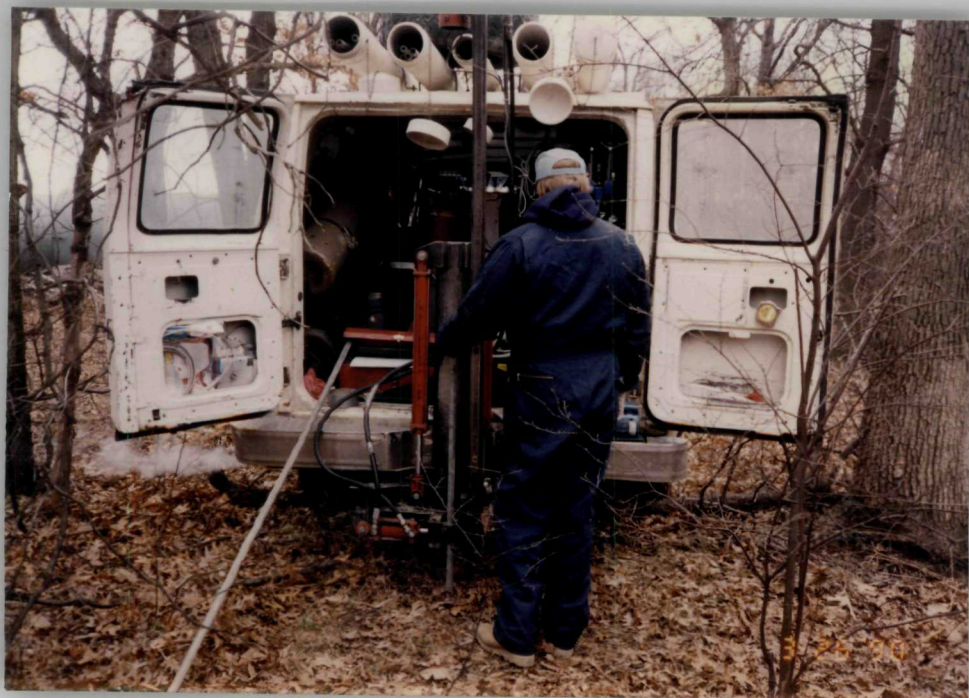
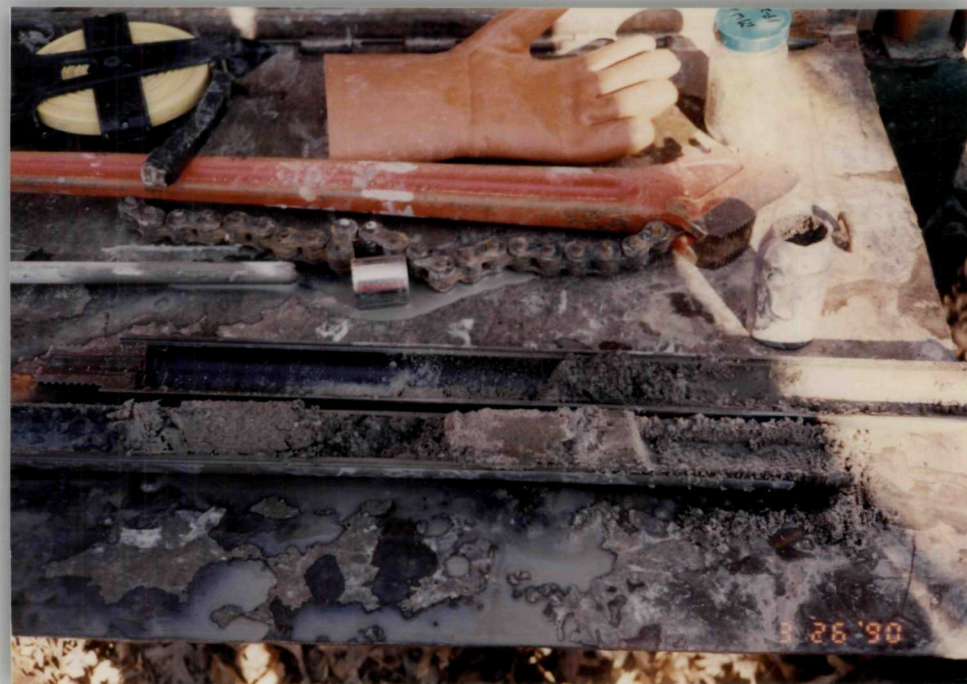
| Number | Description | Date |
|---|--|---|
| R13-1 | Tracer 4 WD van south of drill rig set on MW-10A. View is to north. | 3/26/90 |
| R13-3 | Split spoon sample of MW-10A, 17 to 19 feet; note bottom of clay layer at 18.9 feet. | 3/26/90 |

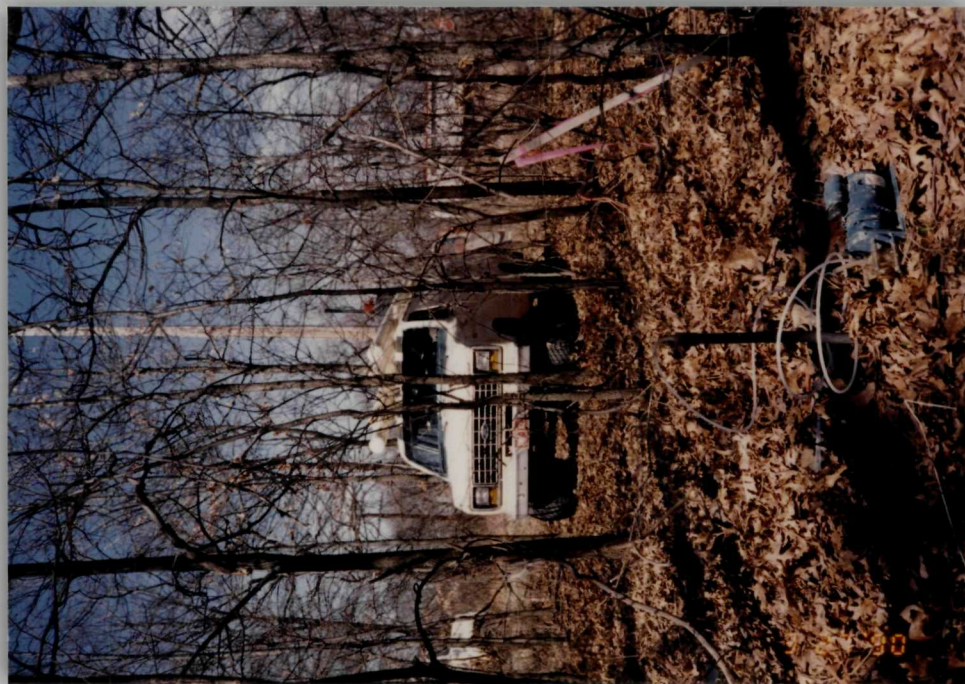
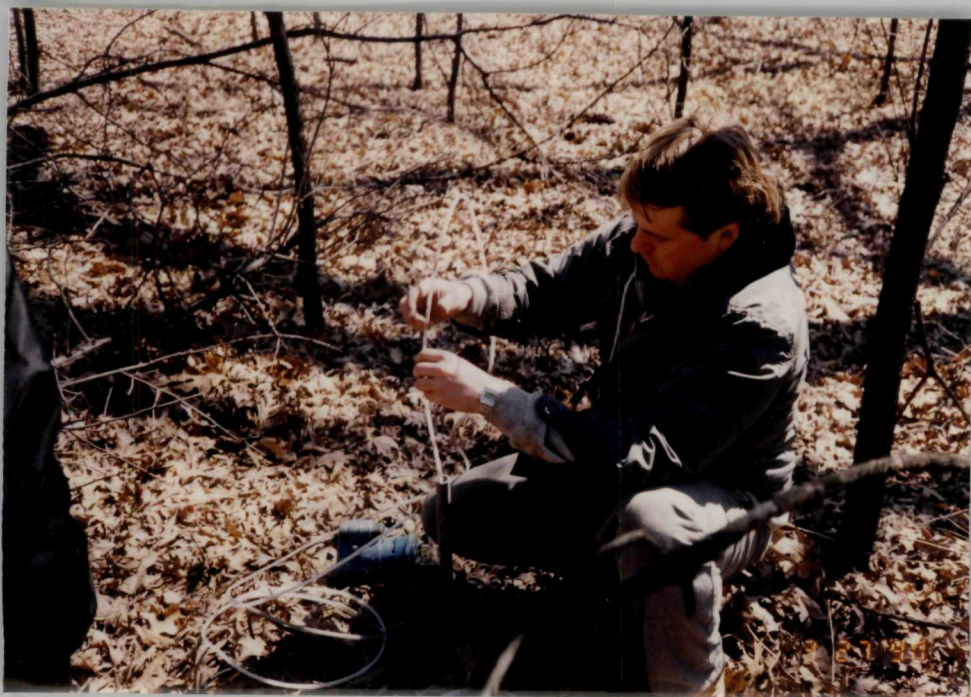
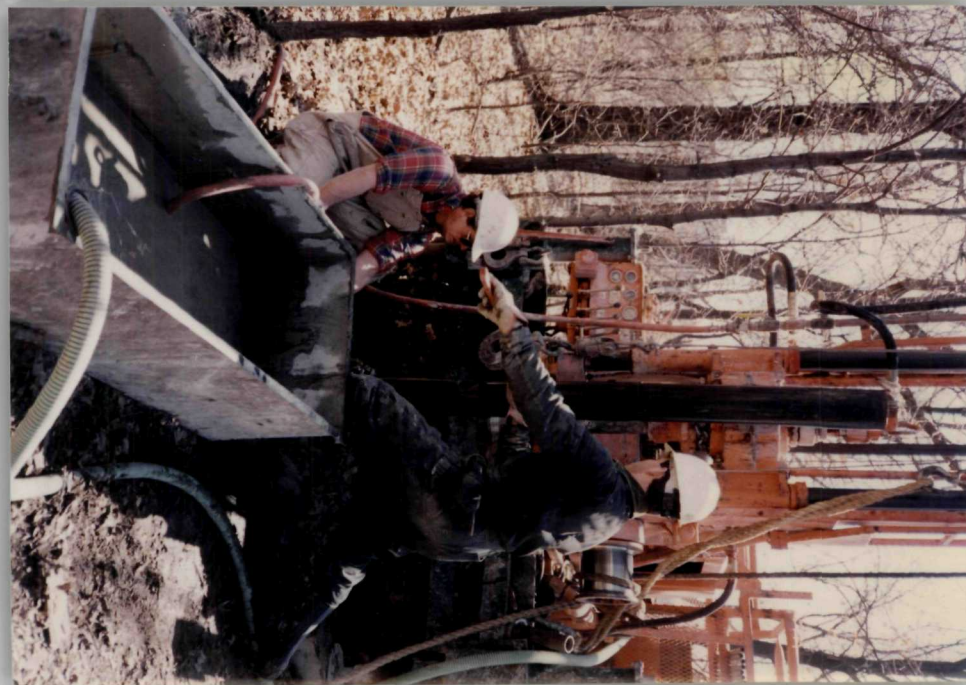
| Number | Description | Date |
|---|--|---|
| R13-7 | Tracer cap system used to create vacuum. View to north-northwest. | 3/27/90 |
